# **Pentium® Pro Processor Specification Update**

Release Date: May 1998

Order Number: 242689-028

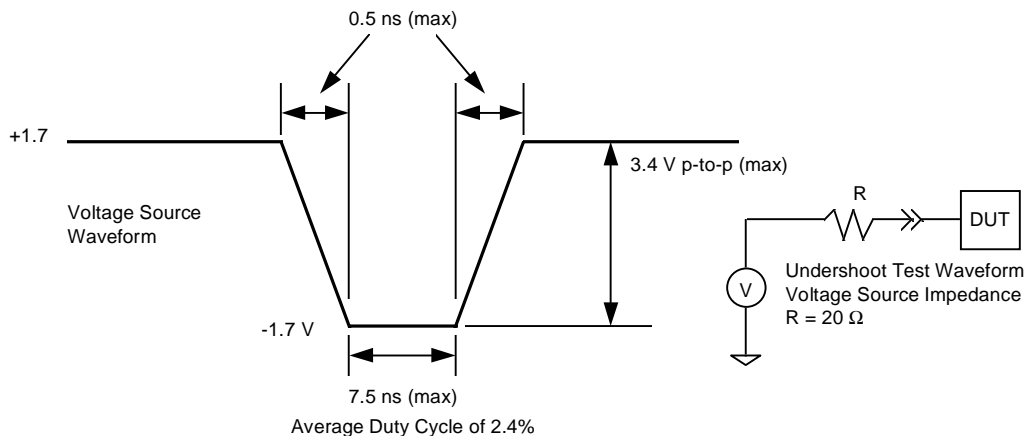
The Pentium Pro processor bus signals AERR#, BERR#, BINIT#, BNR#, HIT#, and HITM# (only) are capable of sinking an 85 mA current pulse at 2.4% average time duty

cycle. This is equivalent to -1.7 V applied to a  $20\Omega$  source in series with the device pin for 8 ns at 66 MHz with a utilization of 5%.

Note: This test covers the AC operating conditions only.

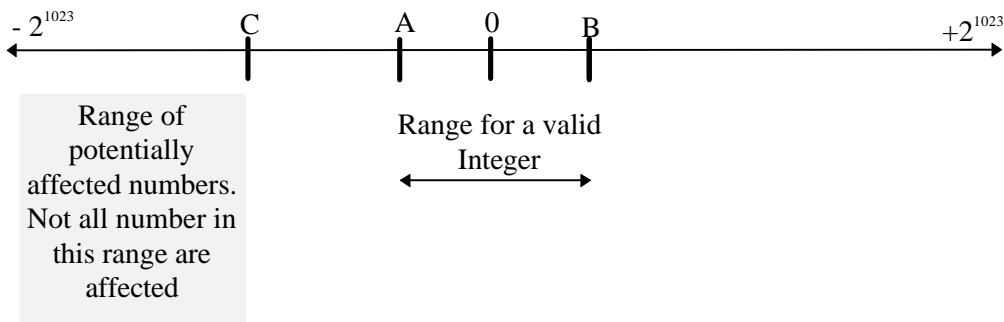
**IMPLICATION:** Erroneous operation results when the operand is so large that it will not fit into the target data size. The operands affected by this erratum are significantly outside (by a factor of 3X) the range that can be, correctly, converted to an integer value. The figure below and corresponding table identifies the normal range of integer numbers (between A and B) and the starting point of the operands affected by this erratum. Discrete failing operands will be present in the range between point C and the maximum negative number that can be represented by the processor ( $-2^{1023}$  in double precision format). Note 2 below gives a qualitative description of the nature of the discrete failing values. Software that does not rely on the Invalid Operation exception flag being set and signaled by either an exception OR by software polling is not impacted by this erratum.

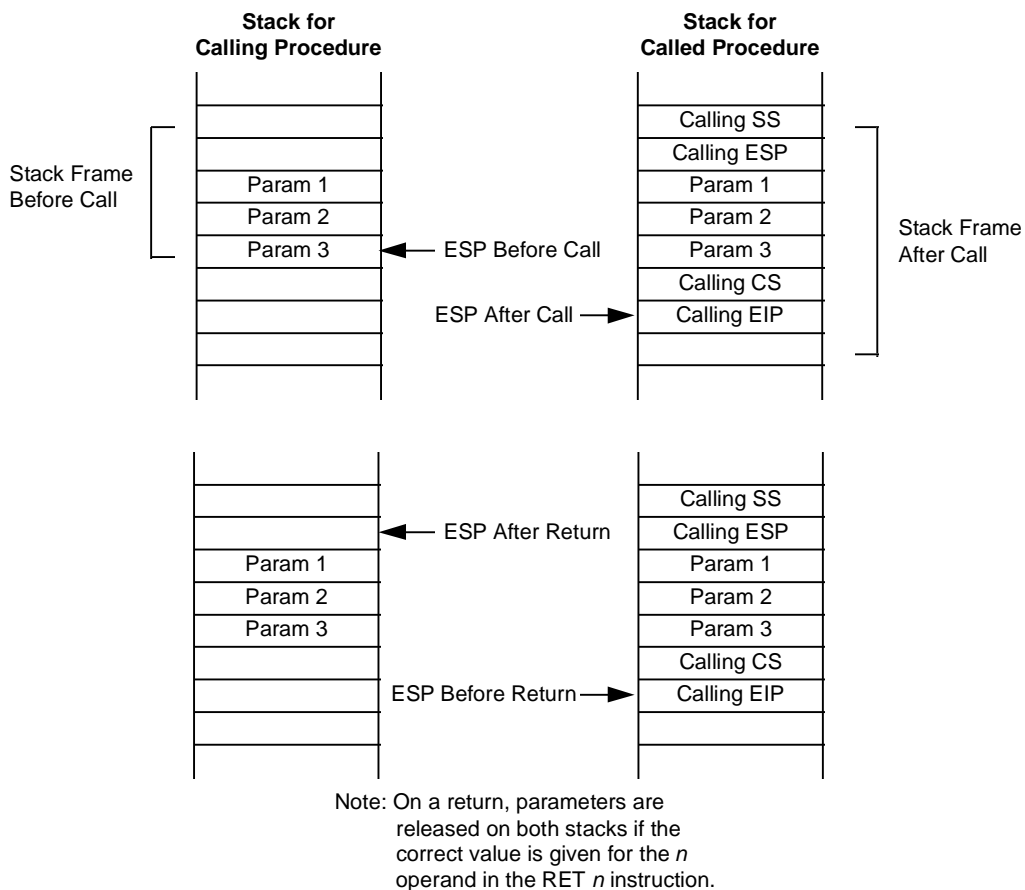
**Figure 4-3. Stack Switch on a Call to a Different Privilege Level**

When making a call to a more privileged protection level, the processor does the following (see Figure 4-3):

6. Resumes execution of the calling procedure.

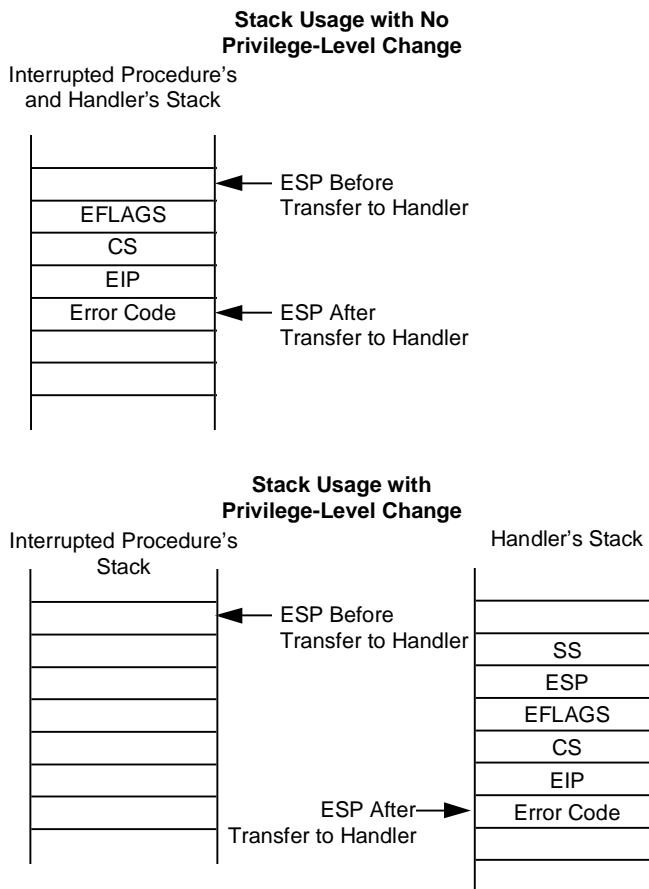
**Figure 4-4. Stack Usage on Transfers to Interrupt and Exception Handling Routines**

4. Restores the SS and ESP registers to their values prior to the interrupt or exception, resulting in a stack switch back to the stack of the interrupted procedure.

5. Resumes execution of the interrupted procedure.
